RE: Foundation Investigation Report on Proposed Dental Facility at Henderson Intermediate School, 70 Lincoln Road, Henderson.

FOUNDATION INVESTIGATION

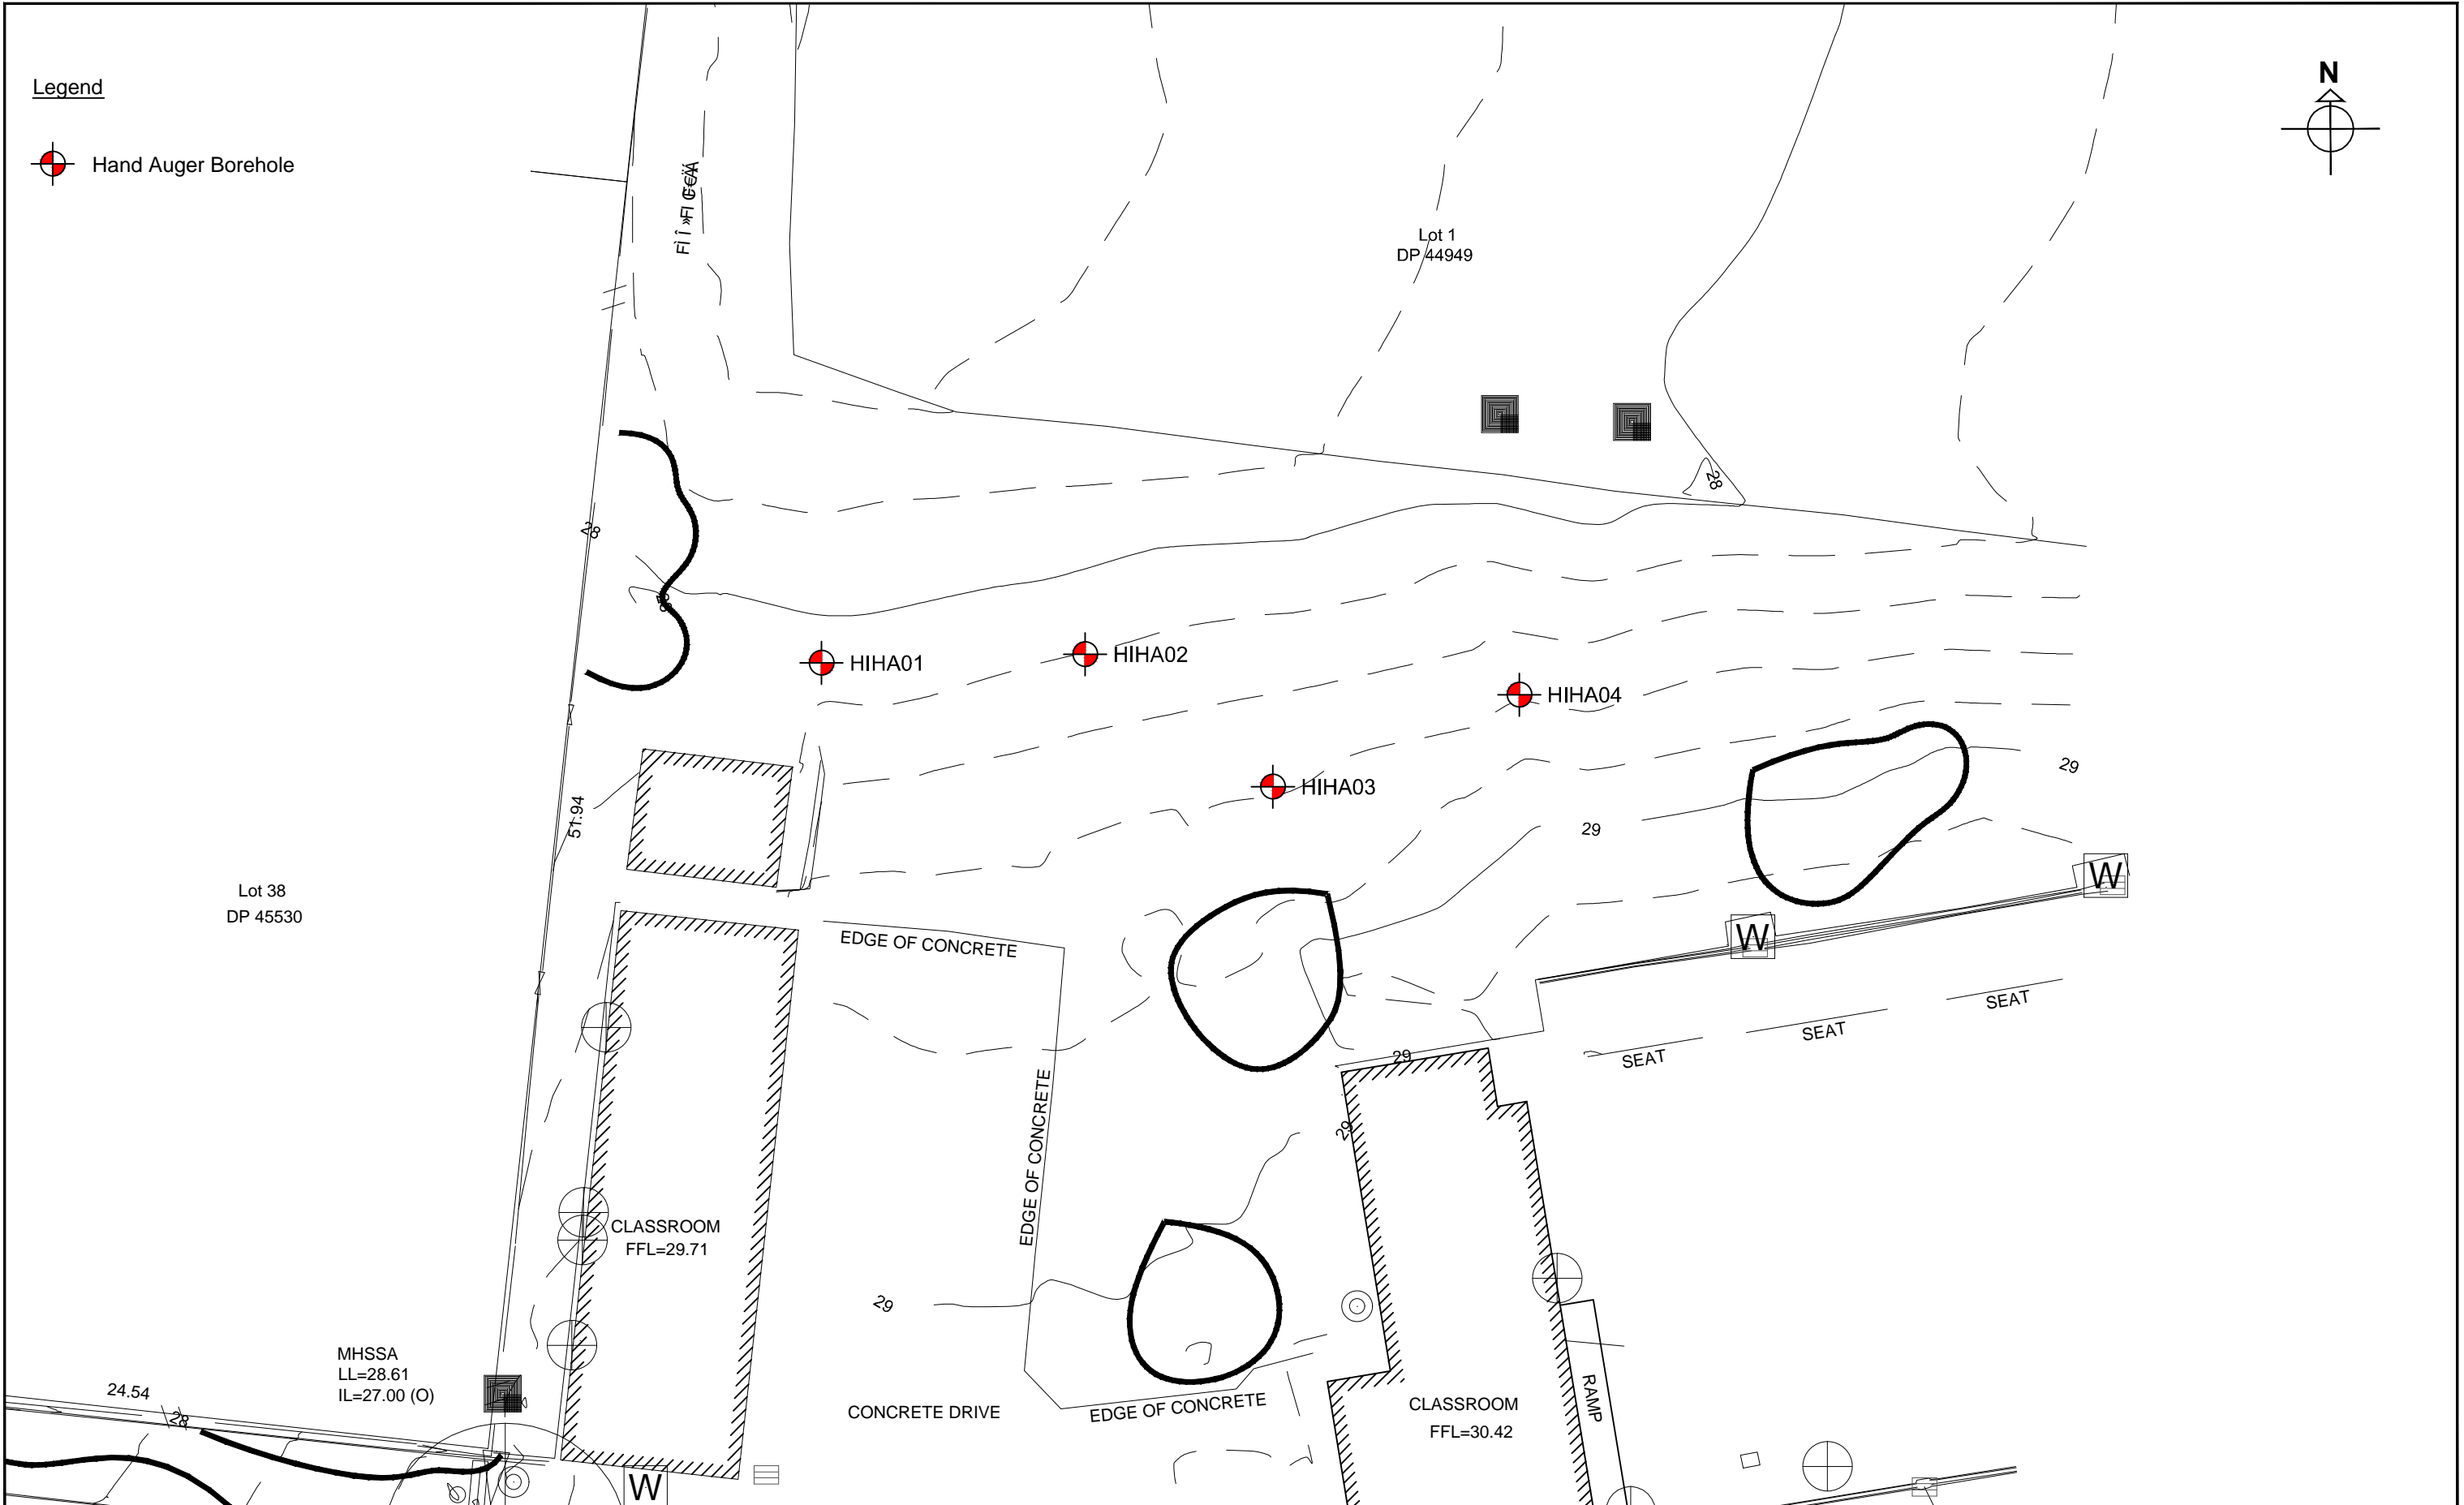
Our fieldwork was undertaken on 5 August 2009 and involved the drilling of 4 hand auger boreholes to depths of up to 3.2 metres in the positions indicated on the appended site plan. A soil sample was also recovered for subsequent laboratory examination and testing.
