**SOIL CONTAMINATION SCREENING
PROPOSED DENTAL FACILITY
HENDERSON INTERMEDIATE SCHOOL**

Report Date: 17 May 2010
Project Ref: ENVINEWP51028

Coffey Environments

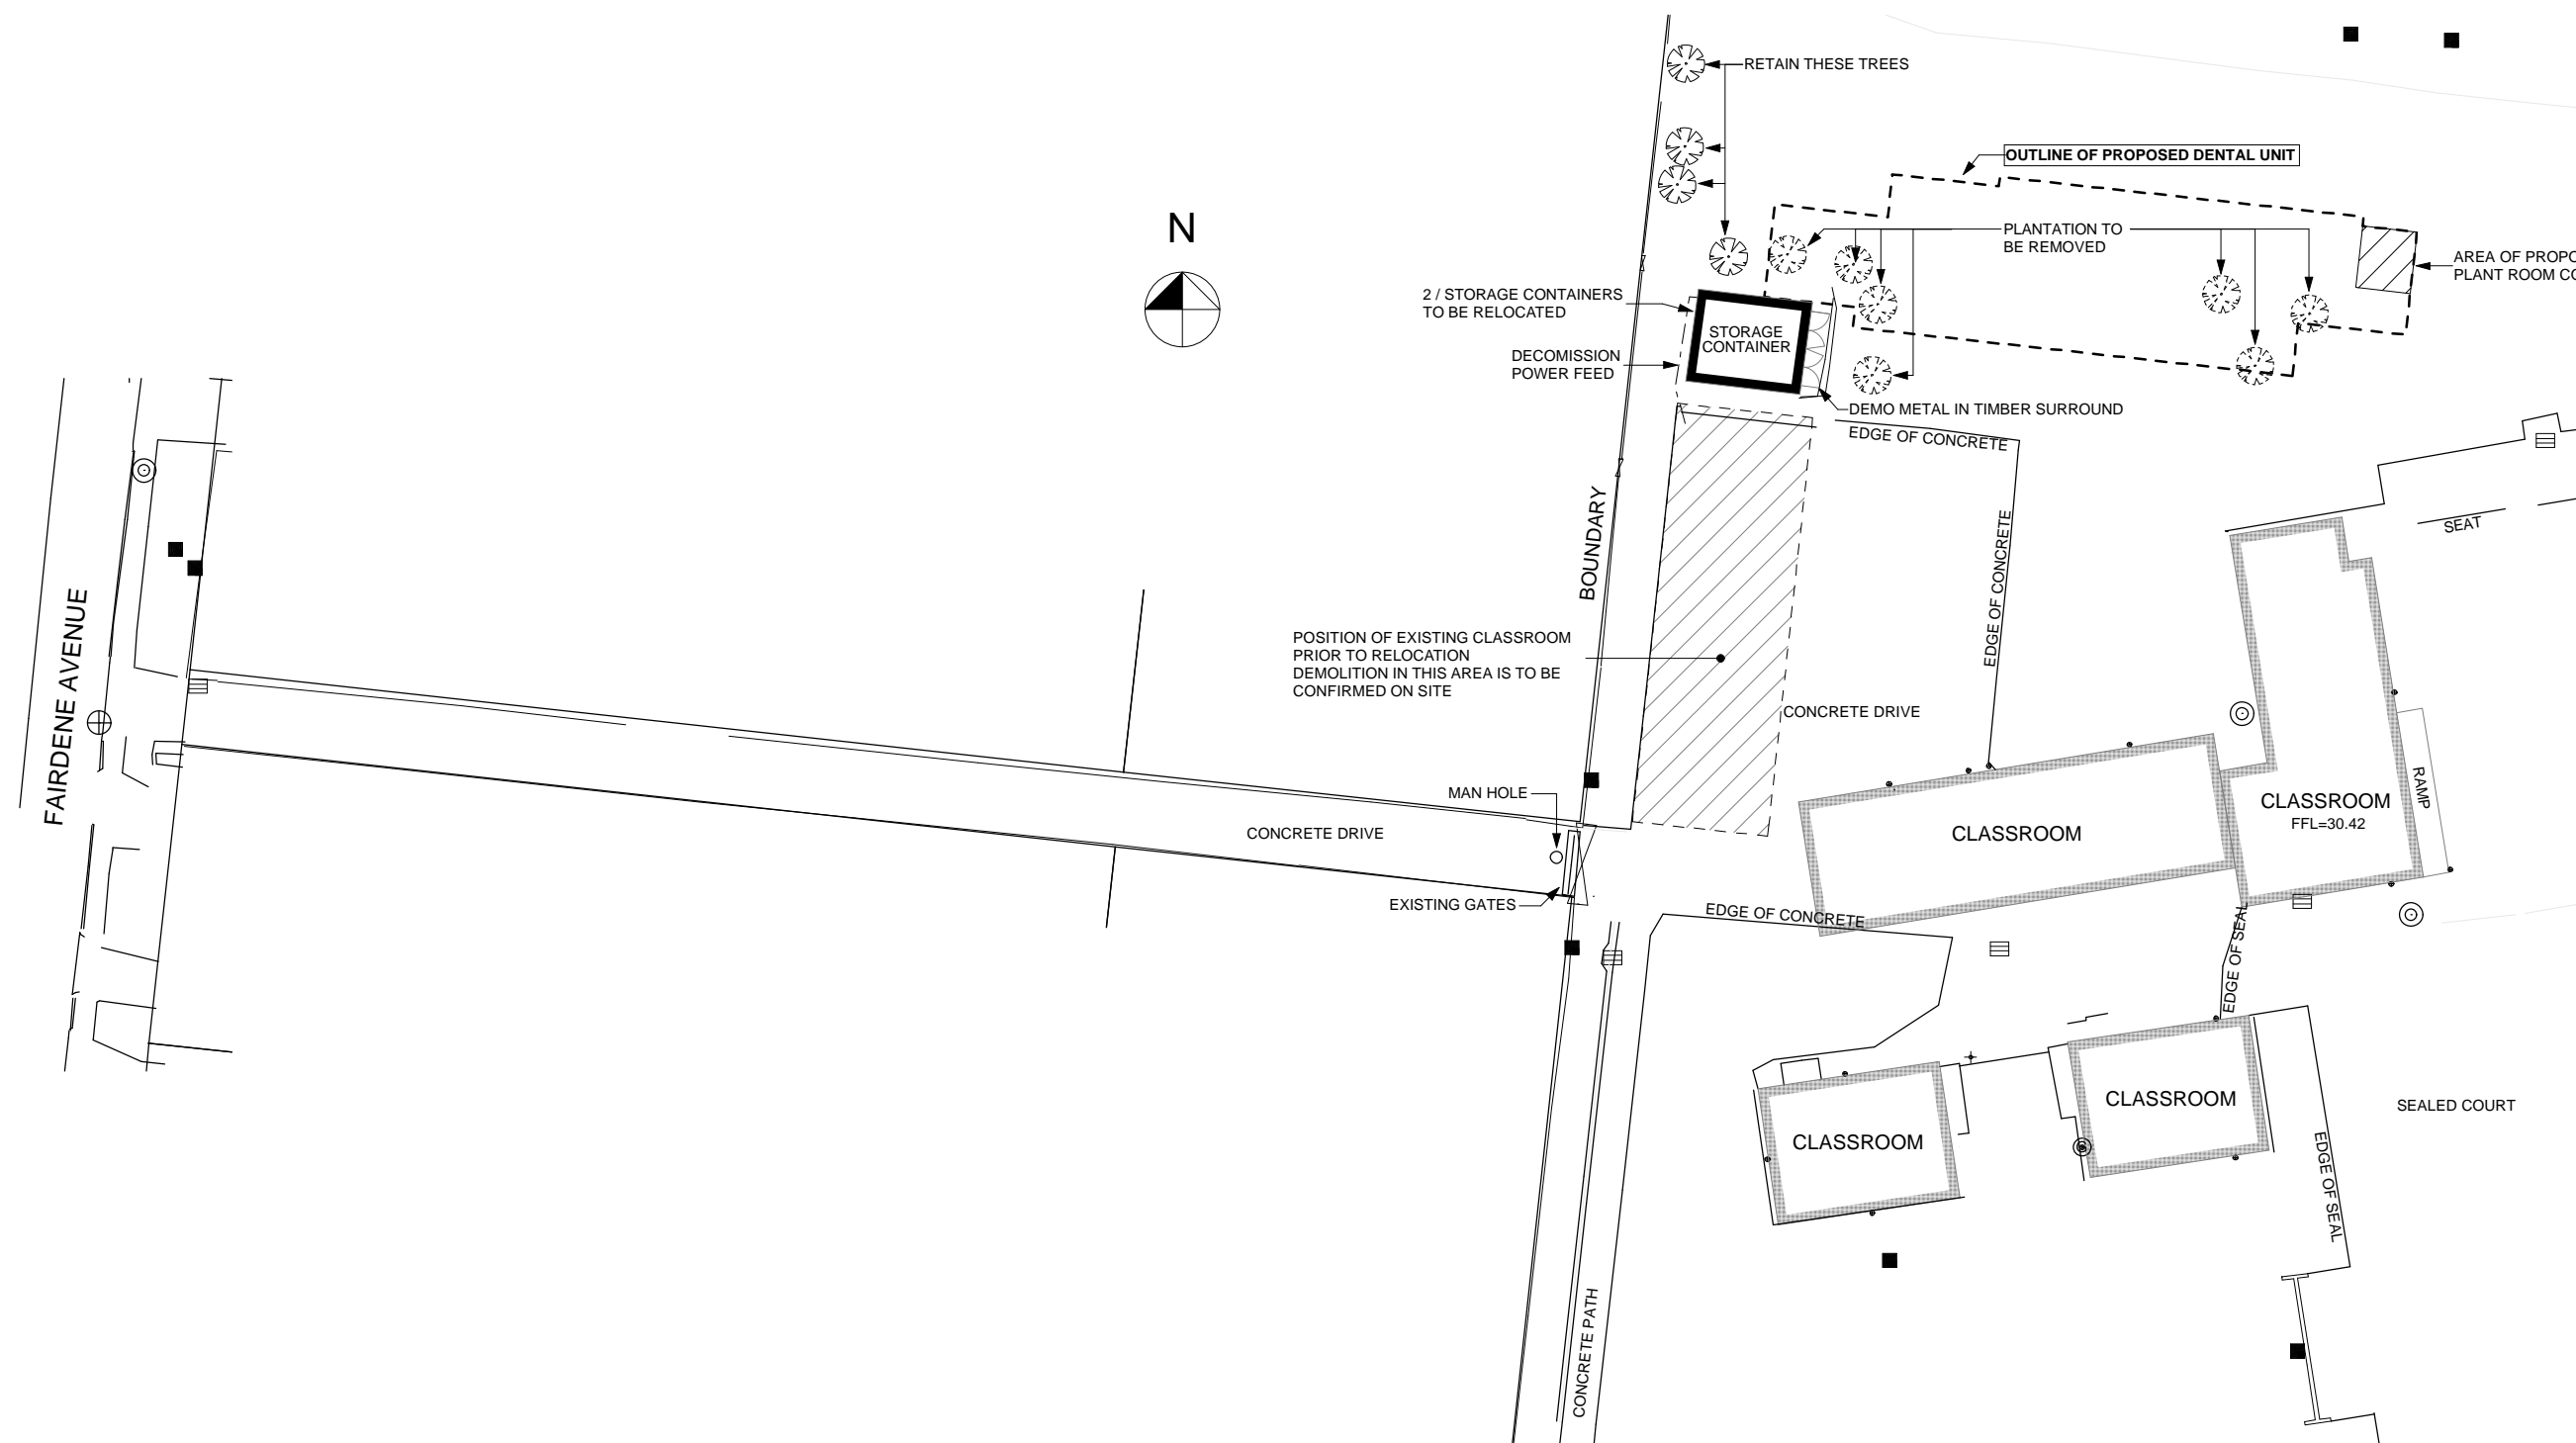
Site Existing / Demo
1:200

The proposed site for the dental facility is located within the Henderson Intermediate School grounds in the south western quadrant of the property, in an undeveloped grassed area immediately south of the playing fields, as indicated in the Kay & Keys architectural outline plan of works (refer to Appendix A).

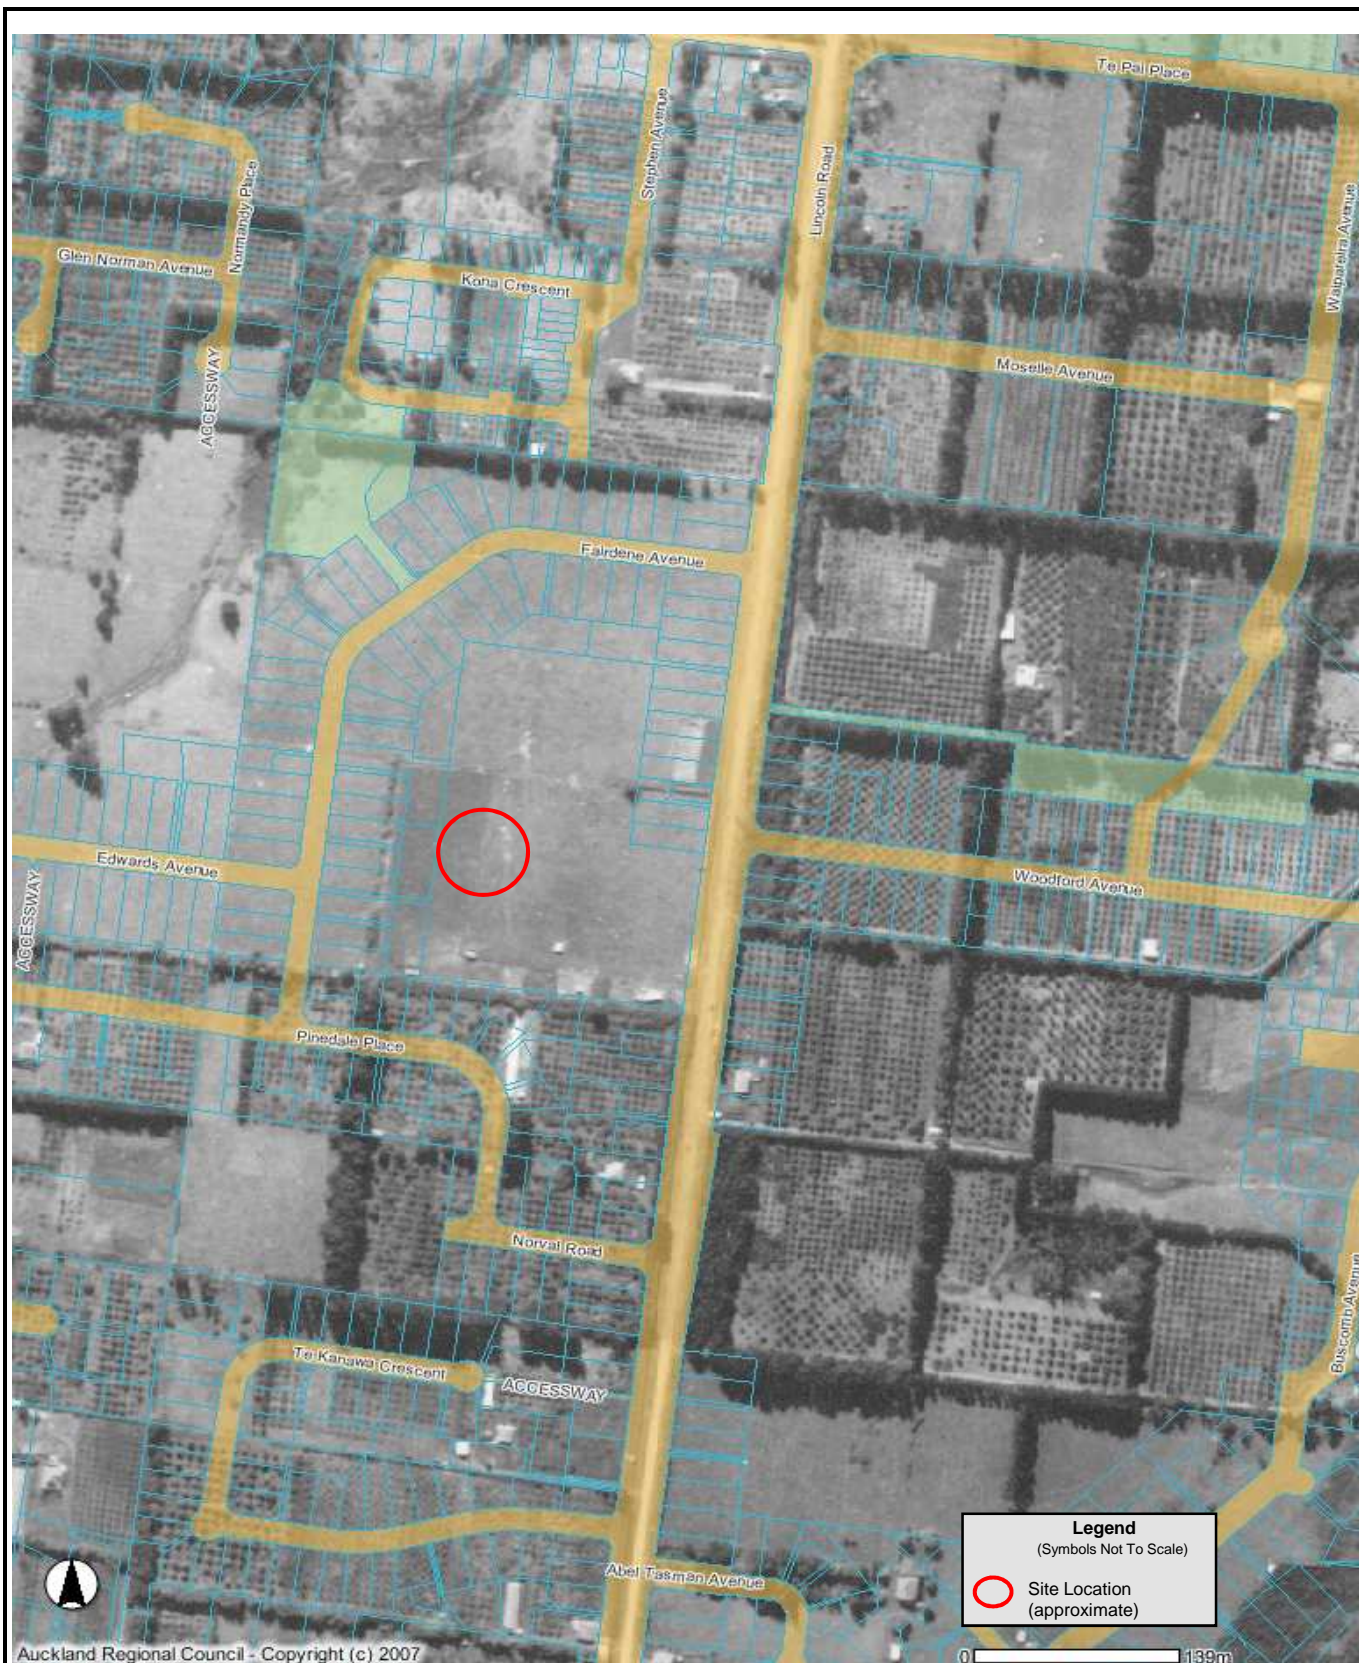
PROJECT: CIVIL/ENVS/1028	DESIGNED: CM	FIGURE TITLE: 1940 AERIAL PHOTOGRAPH
		DWG #: 2	DRAWN: CM	
PROJECT TITLE: HENDERSON INTERMEDIATE DENTAL FACILITY		REVISION: 1	STATUS: DRAFT

Historic aerial photographs (refer to Appendix B) indicate that neighbouring sites were utilised for horticultural purposes between at least 1940 and 1959. Horticultural activities are considered a potential source of heavy metals and organochlorine pesticides (OCPs). However, no other potential sources of contaminants are evident in the immediate vicinity of the site with the more recent commercial uses of the adjacent properties considered unlikely to have impacted the site given the separation and typically low permeability ground conditions associated with fine grained materials observed on site (refer to Appendix C).
